Harlan County Dam Tainter Gate & Irrigation Repairs

*John Grothaus,
Chief, Plan Formulation
Kansas City District*

August 22, 2017

Republican River Compact annual meeting

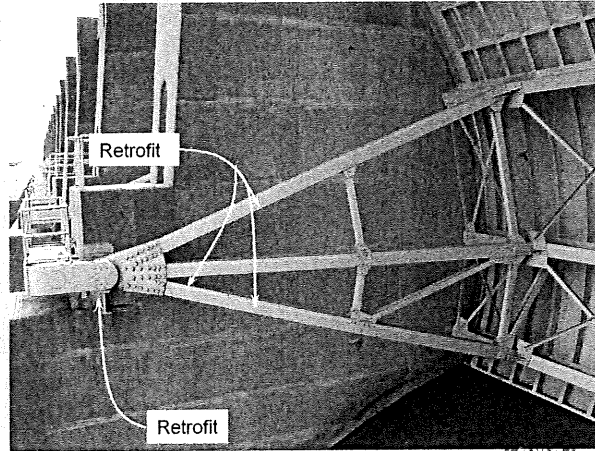
All 18 spillway Tainter gates have been restricted due to issues with the bearings, strut arms, lifting chains, and electrical controls. The Harlan County Dam is currently operating under an interim operating plan that has reduced the flood control pool by 54 percent. The much needed repairs will allow the project to return to normal operations during floods.

The structural repairs focused on the strut arms and bearing arm of the tainter gates. Cover plates were welded to the main strut arms. The struts were cut near the bearing arm. The bearing arms were replaced with a fabricated bearing arm, was welded back to the strut arms. To minimize the time the tainter gate was unsupported by the trunnion, the Contractor was required to field verify all dimensions of the bearing arm and fabricate new bearing arms prior to cutting the strut arms. The new arms were onsite before cutting the strut arms.

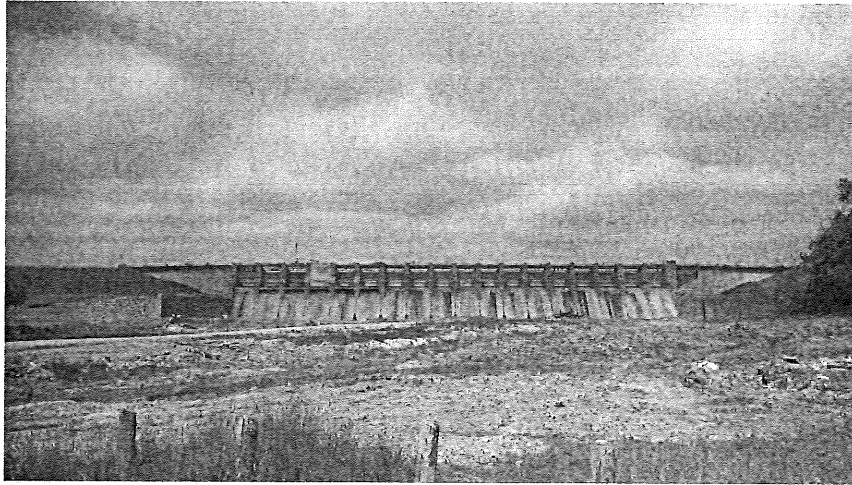
June 2017 – Painting Tainter Gate 15. Media Blasting Painting Now
Completed on Gates 1-17. Structural Repairs Complete All Gates 1-18

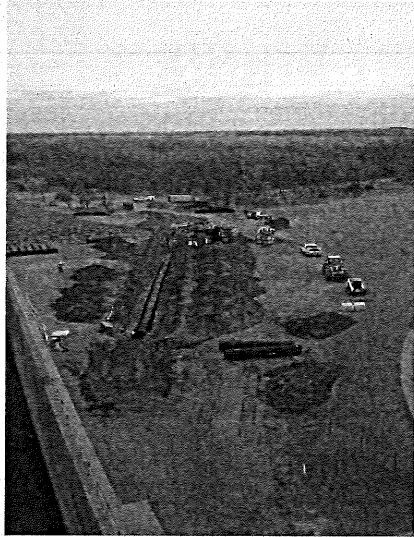
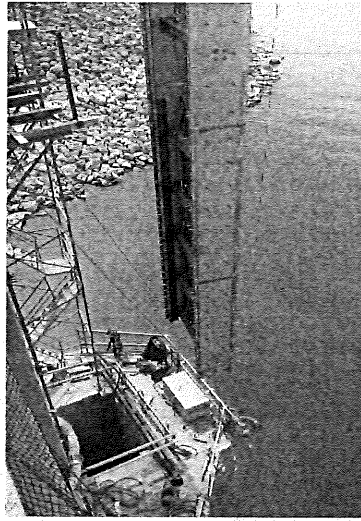
Winter 2016/2017 – 700 LF of Naponee Irrigation Conduit Was Replaced & New Lined Slots for Irrigation Stoplogs and Trash Racks Were Constructed
