# KANSAS DAMS

## REMOVAL

Regulations, Considerations, and Design Aspects

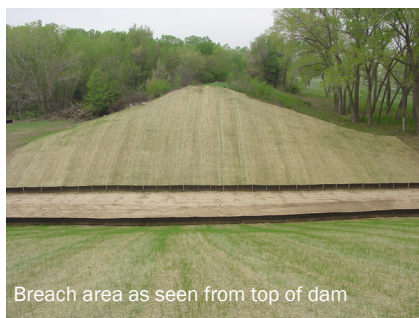
Breach area as seen from top of dam

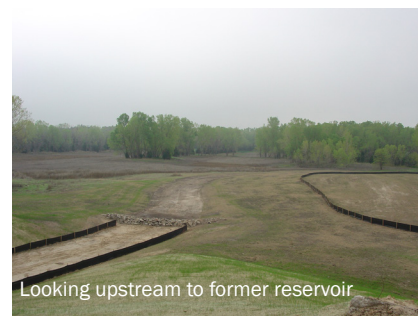
Looking upstream to former reservoir

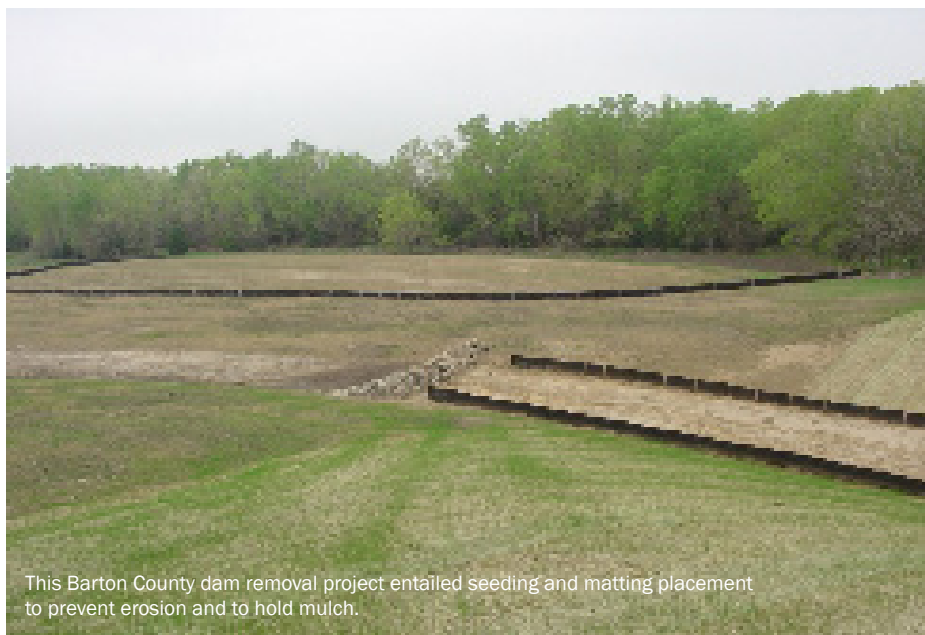
This Barton County dam removal project entailed seeding and matting placement to prevent erosion and to hold mulch.

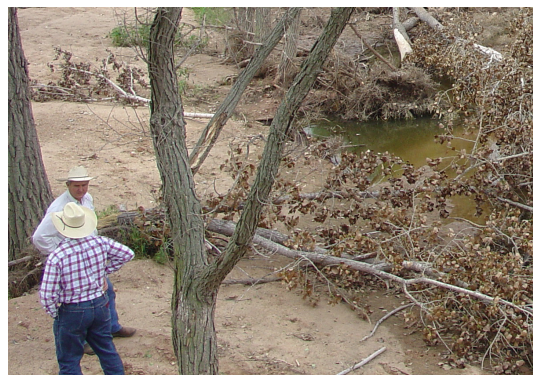
**Clark County.** During excessive rain over several weeks, a piping failure with a 25' breach width caused this 27' dam to fail. The released wastewater from the livestock lagoon overtopped a county road 1/2 mile downstream with 2' to 3' of water and took out 500' fences on both sides of the road. Division of Water Resources informed the owners to remove the structure or plan for its repair. The feedlot owners chose to remove the dam that had a drainage area of 10177 acres with a surface area of approximately 12.3 acres. The owners stabilized the area downstream with berms, dykes, and channelization to protect the area.

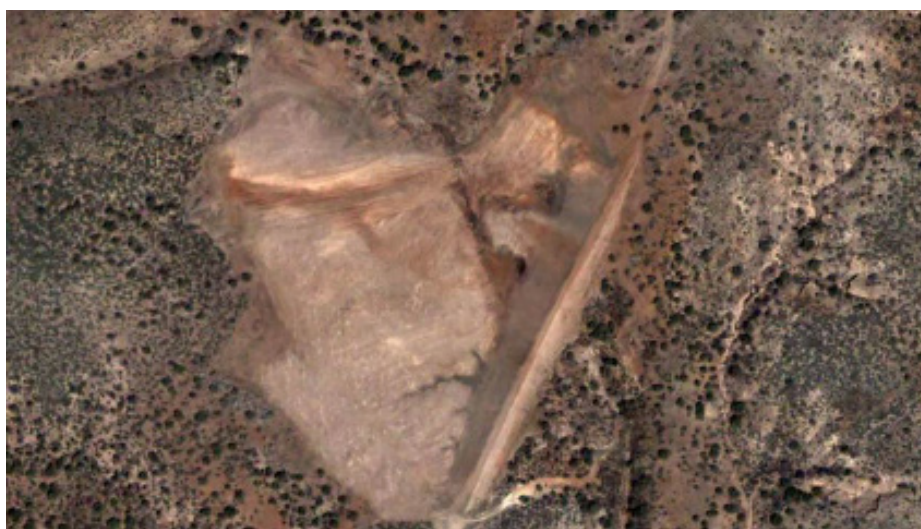
Aerial photograph of one of the Arizona unpermitted dams removed by the owner with engineering oversight.

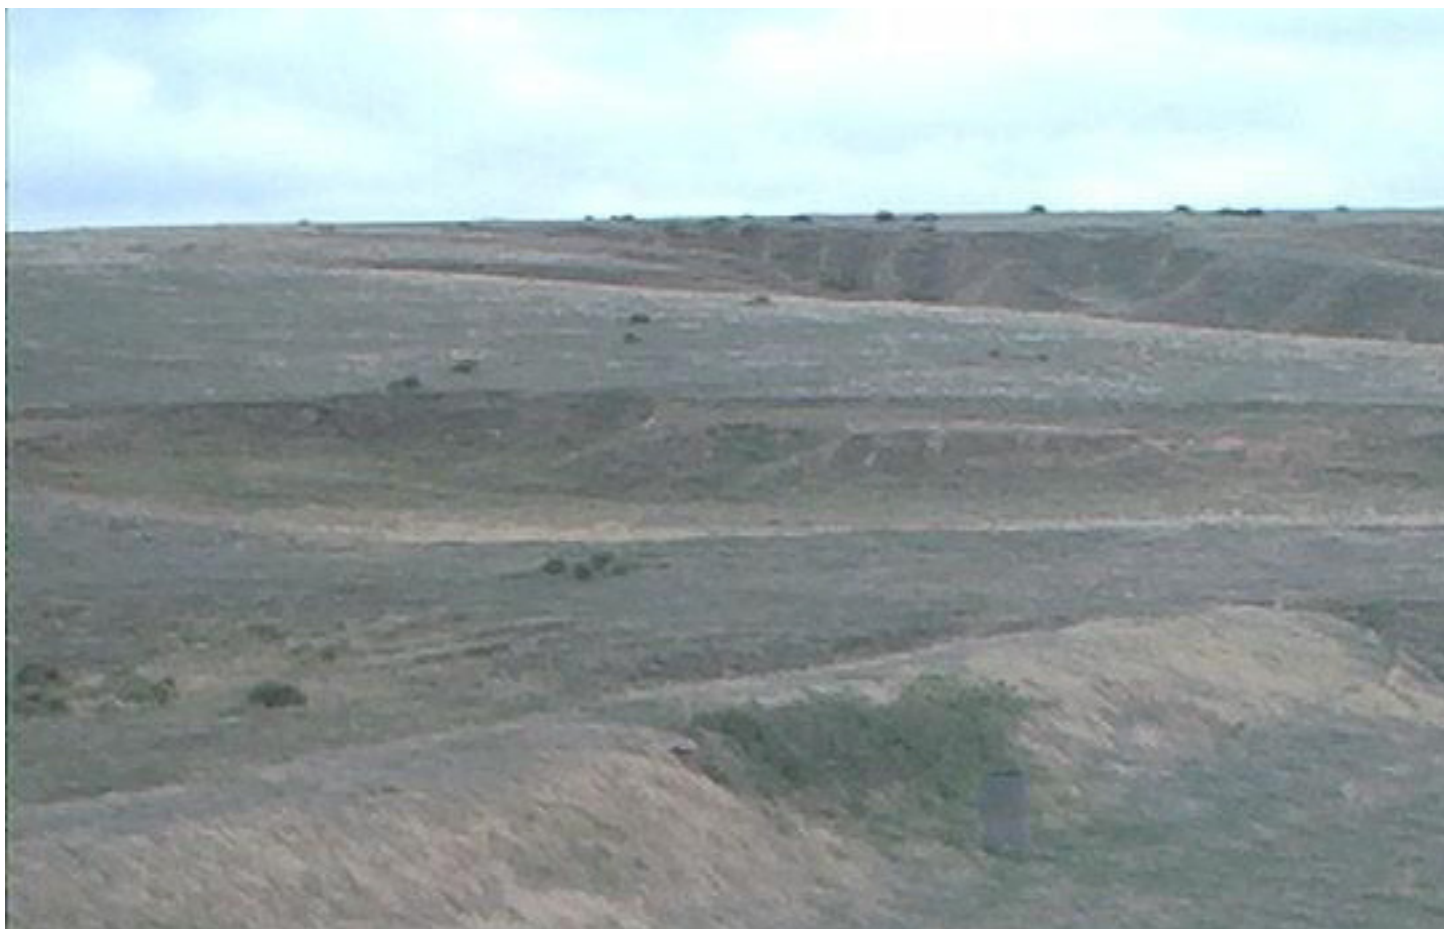
This dam located in western Kansas 350 feet upstream of highway was found to have severe erosion at the outlet of the principal spillway pipe that extended up into the downstream slope and was approaching the crest of the dam.

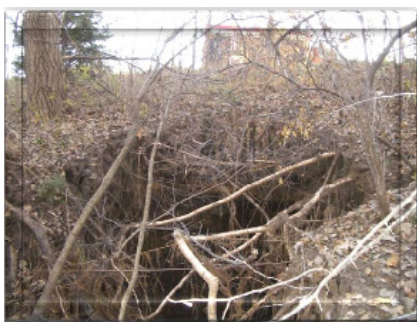
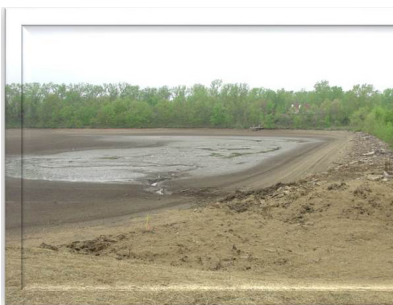
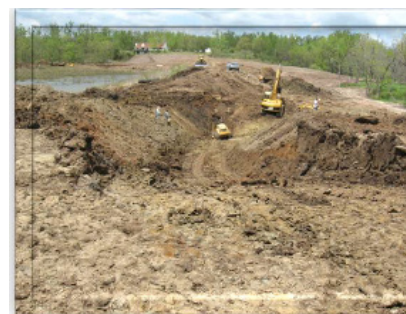
**Jackson County.** Erosion and other problems caused this failing dam. The downstream embankment suffered major damage during a storm event and piping failure. The primary spillway pipe separated into multiple pieces back into the embankment area. A loss of material within the embankment created a void of a volume equal to approximately 200 cubic yards and dam in danger of complete failure.

An emergency order to begin draw-down of the lake was issued and executed the next day by removal of the cover plate on the 6-inch drawdown pipe. The order also required temporary repairs of the auxiliary spillway, evaluation of the dam and primary spillway by a licensed professional engineer and weekly monitoring of the dam until completed draw-down.

The owners preferred to breach the dam rather than repair it. Initially, they planned to use their own equipment to remove the dam but later bid out the construction work bid. The removal was halted when the local watershed decided to take over dam ownership but first had the dam cored to help them make their determination to adopt the dam or not.

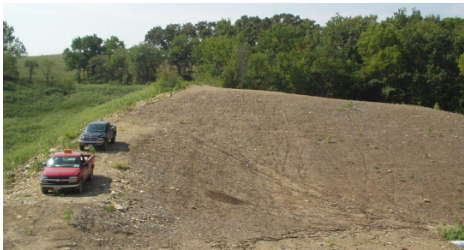
After a pipe siphoned the water in the breach, the former lake was essentially a large mud hole,” King said.

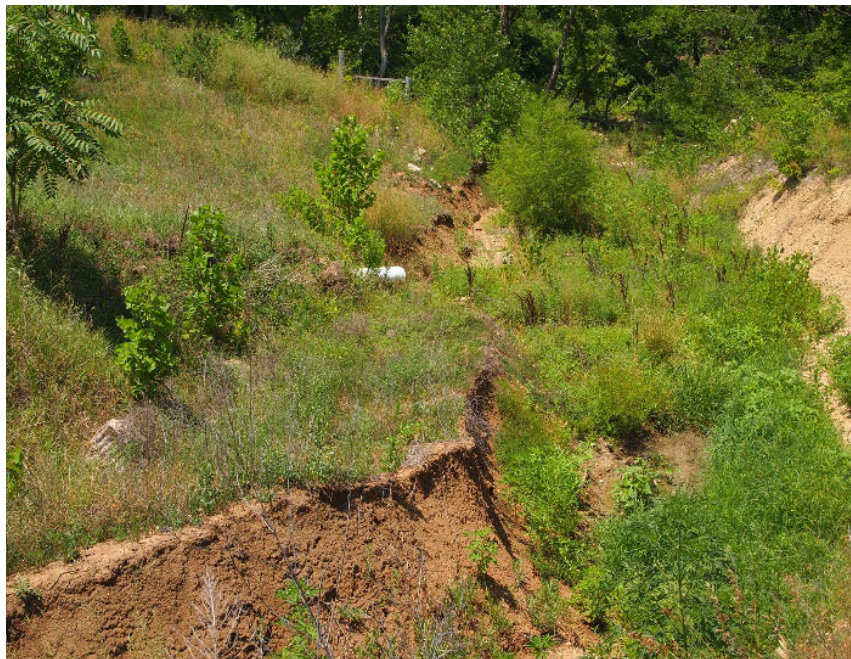
Once, the lake drained, the city didn’t do anything else to the area, which now has significant erosion.

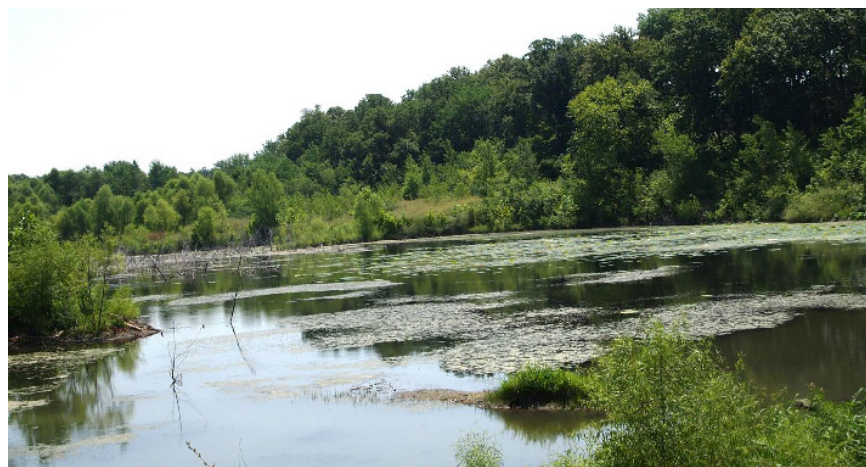
Since the dam has been removed, a stream channel developed during the first year as has a wetlands area encompassing two or more acres.
