Item 113 Justification Form | Bridge Owner

NBI Structure Number	WSN GSW 0104	Owner	GREENWOOD
County Structure Name	30TH ROAD CULVERT	Year Constructed	2017
POA Required?	☐ YES/NO ☑	Feature Intersected	STREAM
Date Delivered	3/15/21	Facility Carried	30TH ROAD
Critical Inspection Finding?	☐ YES/NO ☑	Location	3.1 MI EAST 2.O MI NORTH PIEDMONT
Date Delivered	N/A

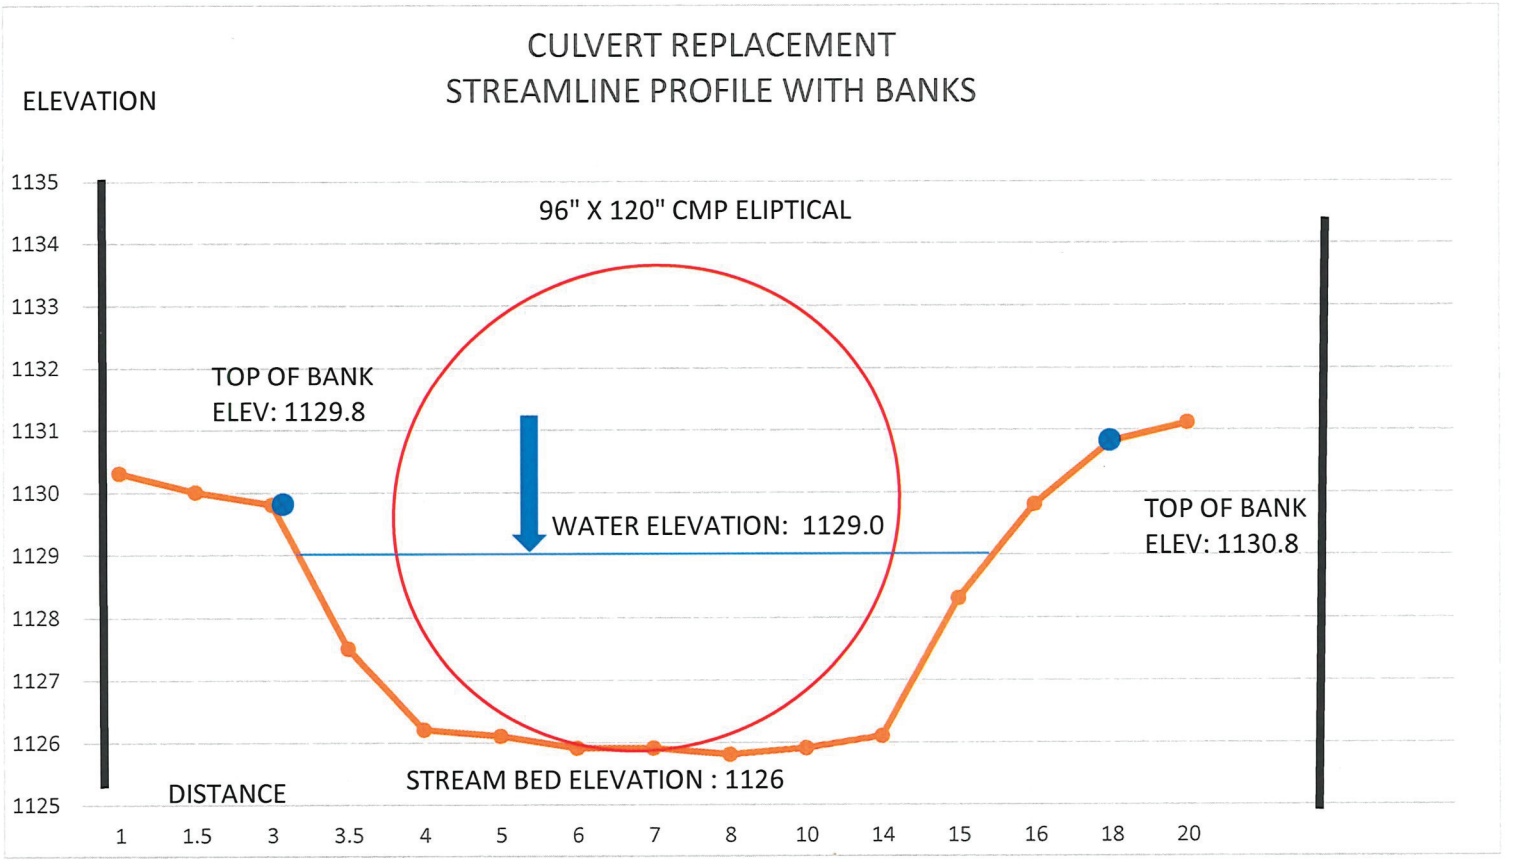
WSN SGW - 0104

CMP CONSTRUCTED IN 2017. OBSERVED SCOUR ON NORTH OUTLET OF 18", PINNED RIP RAP COUNTER MEASURE IN ACCORDANCE TO HEC-18 STANDARDS RECOMMENDED.
