Harlan County Dam Tainter Gate & Irrigation Repairs

*John Grothaus,
Chief, Plan Formulation
Kansas City District*

August 22, 2017

Republican River Compact annual meeting

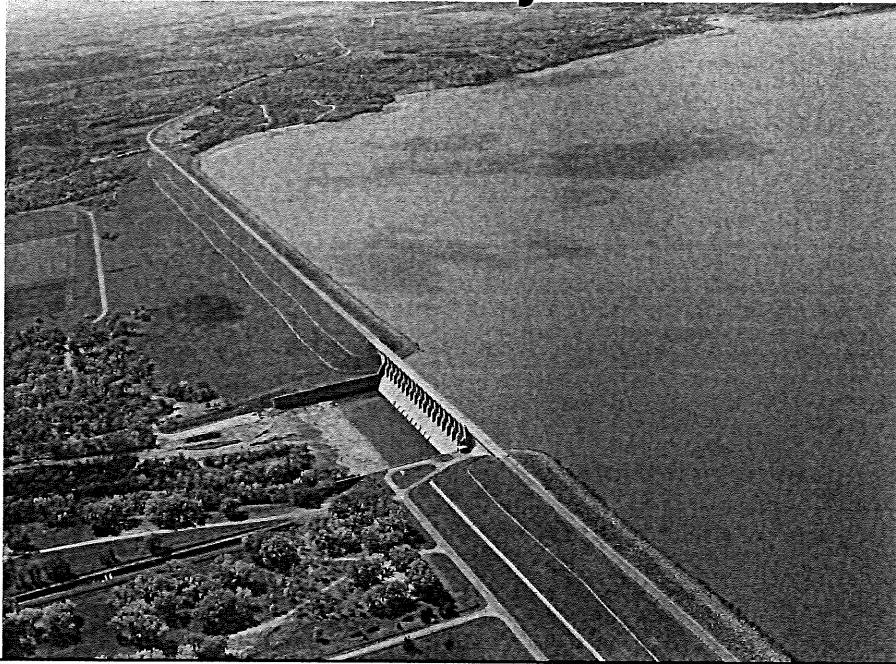
Harlan County Lake's dam is almost 12,000 ft long. Maximum height 107 feet with an 856 ft long spillway. The spillway is controlled by 18 spillway gates requiring retrofitting. Each tainter gates are 40 ft wide and about 30 ft tall. Note the long approach to the spillway and the steepness of the ogee.

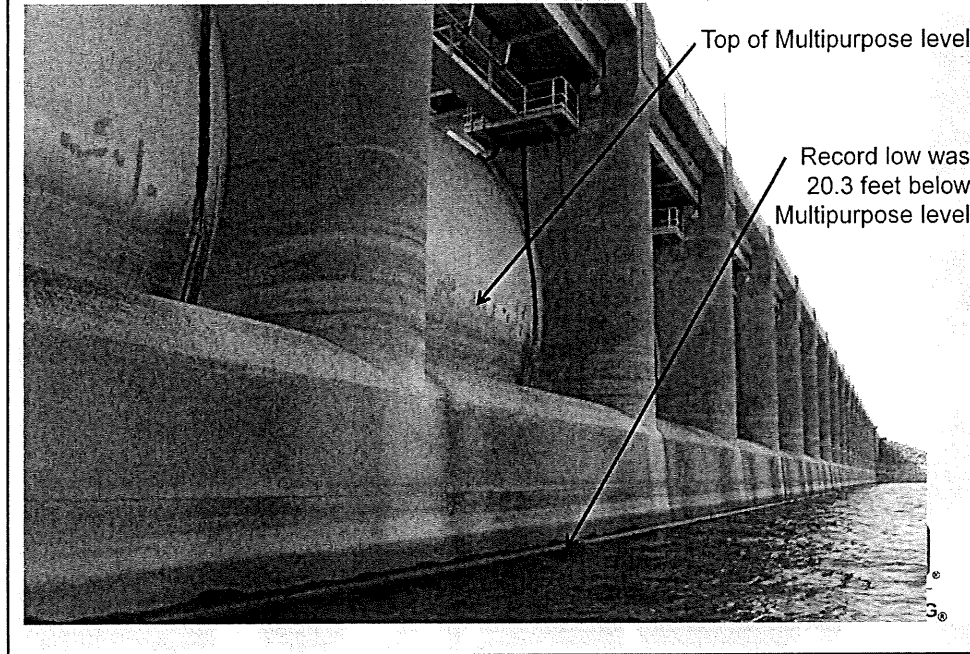
- Top of Multipurpose Pool (1945.73 after May 2001) / Normal water level is 2.5+ feet on gates
- Pool Level on 8/09/2017 was 1939.11 or 6.62 feet below multipurpose.
- Record High Pool: April 5, 1960: 1955.66
- Record Low Pool was 20.3 feet below normal pool – 1925.4 msl in Dec 2004.
- The dam was constructed without a dewater system. Therefore, the first phase of the repairs was constructing stoplogs, guides, support beams and the anchors & anchor pads on the face of the dam so that work can be accomplished during normal pool elevations.

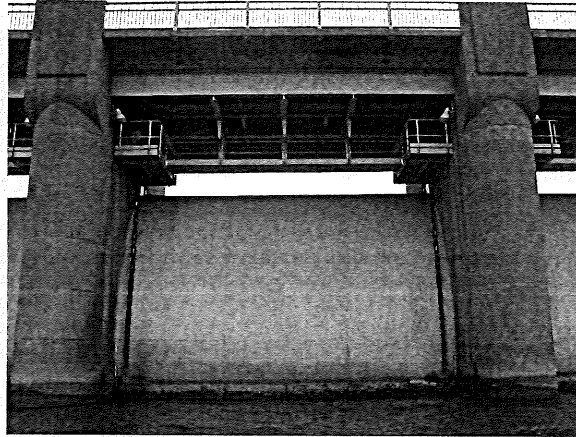
9 - Sluiceways

- Low/normal release
- 18 gates
- Each gate 5' x 8'
- 1 low flow bypass

2 - Irrigation conduits

18 - Tainter gates

- Flood control release
- Each 40' x 30'
