Dam Inspections

The What and Why

Larry J. Schieferecke
Civil Engineer, Salina, Kansas

*United States Department of Agriculture
Natural Resources Conservation Service*

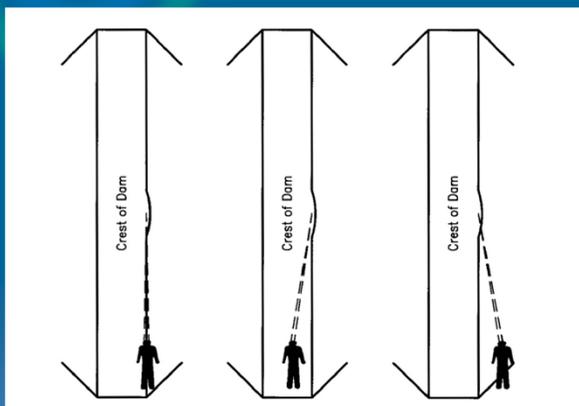
➤ Non-uniform crest & slopes

- Can identify by sighting along dam from one end and from a point partway down the side slope of embankment
- May indicate slides or non-uniform settlement

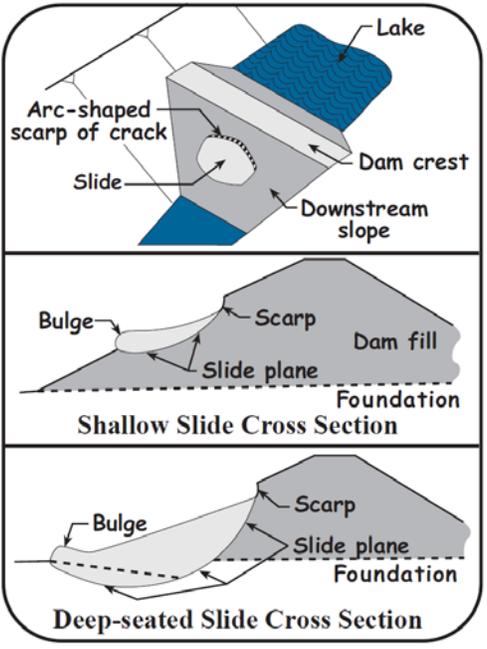
The diagram illustrates three types of dam failure:

- Top:** A 3D perspective view of a dam with a lake. It shows an 'Arc-shaped scarp of crack' on the upstream side, a 'Slide' area on the downstream slope, the 'Dam crest', and the 'Downstream slope'.
- Middle:** A cross-section labeled 'Shallow Slide Cross Section'. It shows a 'Bulge' on the upstream side, a 'Scarp' on the downstream side, a 'Slide plane' near the surface, 'Dam fill', and the 'Foundation'.
- Bottom:** A cross-section labeled 'Deep-seated Slide Cross Section'. It shows a 'Bulge' on the upstream side, a 'Scarp' on the downstream side, a 'Slide plane' deeper within the dam fill, 'Dam fill', and the 'Foundation'.

➤ **Instability (slides) caused by:**

- Soil compaction deficiency
- Slope too steep for soil type
- Uncontrolled seepage
- Sudden pool drawdown
- Saturation of embankment

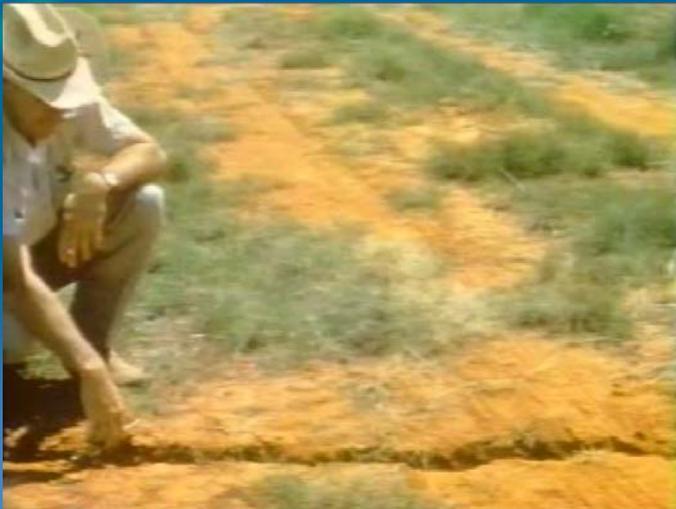
➤ **Transverse cracks**

A photograph showing a person wearing a hat and light-colored clothing crouching on a dirt embankment. They are inspecting a deep, narrow transverse crack in the soil. The background shows a grassy area with some dry patches.

- Perpendicular to length of dam
- Caused by differential settlement
- Can result in high seepage rates and piping through dam, especially if they extend into core of dam

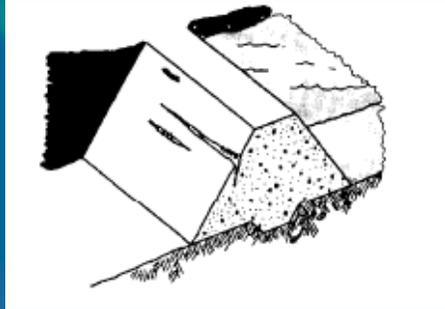
➤ Longitudinal cracks

- Parallel with length of dam
- Caused by drying and shrinkage of surface material or
- Downward movement or settlement of zoned fill
- Can be early warning of potential slide

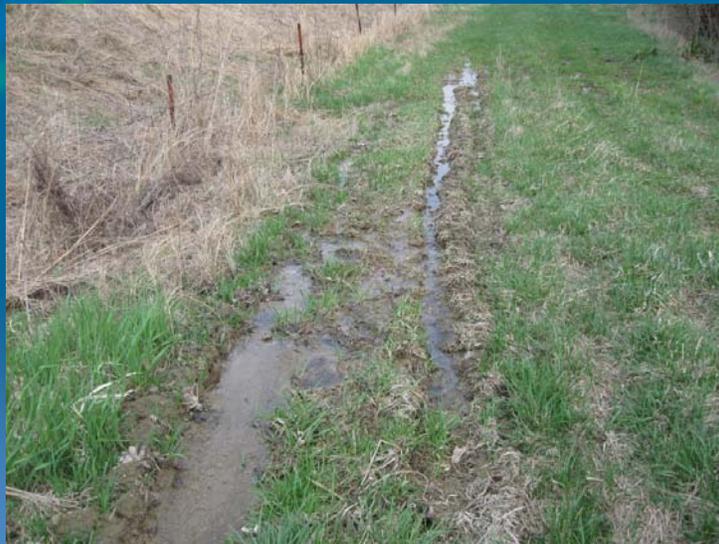
➤ Seepage

- All embankment dams experience movement of water through the embankment and/or foundation soils
- Seepage may be controlled by drains, embankment cores, and cutoff trenches
- Seepage becomes a problem when
 - Embankment or foundation soils are moved by the water flow—results in internal erosion or "piping"
 - Or when excessive pressure builds up within dam or foundation—results in instability

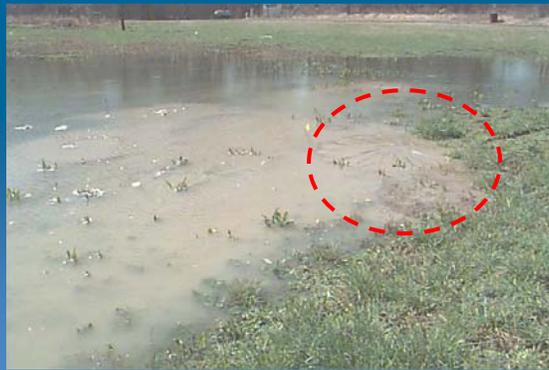
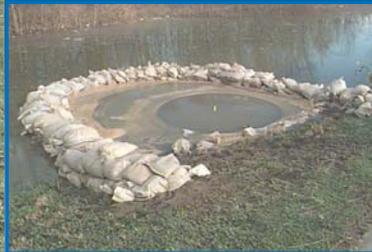
➤ Other signs of seepage problems

- When seepage appears in a location you have not noticed previously or is substantially larger
- When seepage flows appear cloudy, carrying soil particles out of the embankment or a downstream boil point

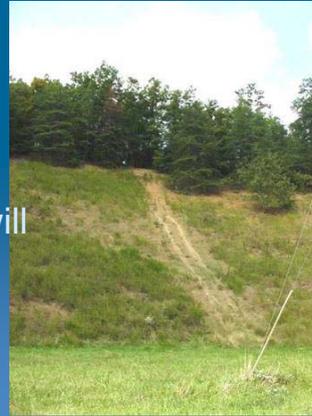
➤ Vehicle traffic on embankment

- Should be limited, especially during wet weather
- Results in vegetation damage and erosion
- Ruts that pond water increase embankment saturation, decreasing stability
- ATV's travelling up and down slopes are particularly damaging—dam overtopping will likely breach here.

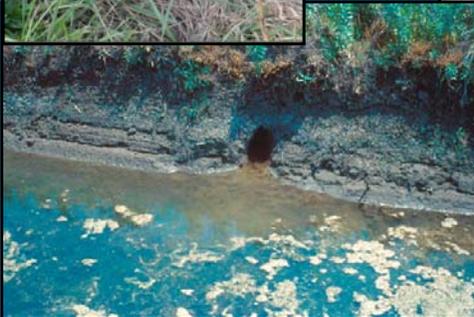
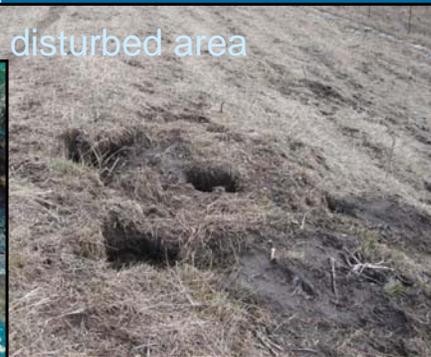
➤ Burrowing animal activity

- Eradicate burrowing animals from dam
- May require excavation prior to filling holes with compacted material
- Reseed disturbed area

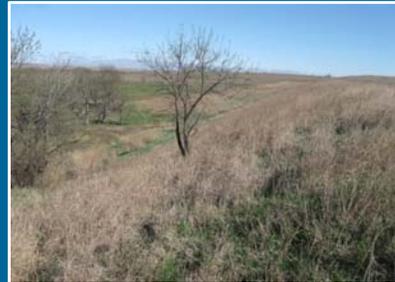
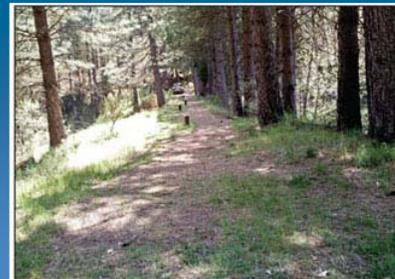
- **Trees – Public Enemy #1**
 - Hinder inspections (limit visibility)
 - Can cause structural instability
 - Lead to internal erosion and piping, especially as roots decay
 - Can clog subsurface drains
 - Shadow and impede grass vegetation
 - Embankment is vulnerable to damage when trees are uprooted during storms
 - Attract burrowing animals
 - Impede flow when present in auxiliary spillway

- **Trees**
 - Remove all trees on the dam, auxiliary spillway, stilling basin, outlet channel, or within 25 feet of toes
 - Larger trees increase risk of failure
 - Large tree removal should include excavation of roots and proper backfill—consult an engineer

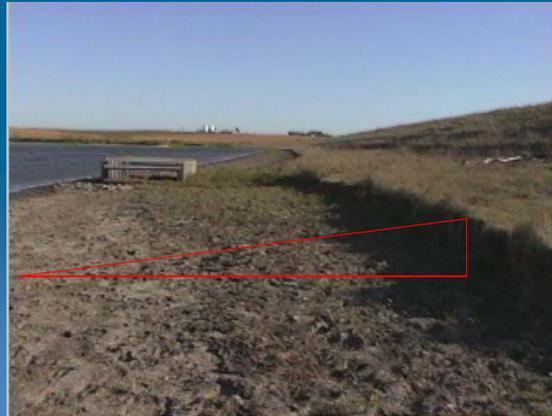
➤ Slope protection

- Vegetation on 12:1 slope (“wave berm”)
 - Requires healthy, water-tolerant vegetation, and livestock exclusion
 - Can be damaged by extended periods of low reservoir levels since vegetation type depends on sufficient water

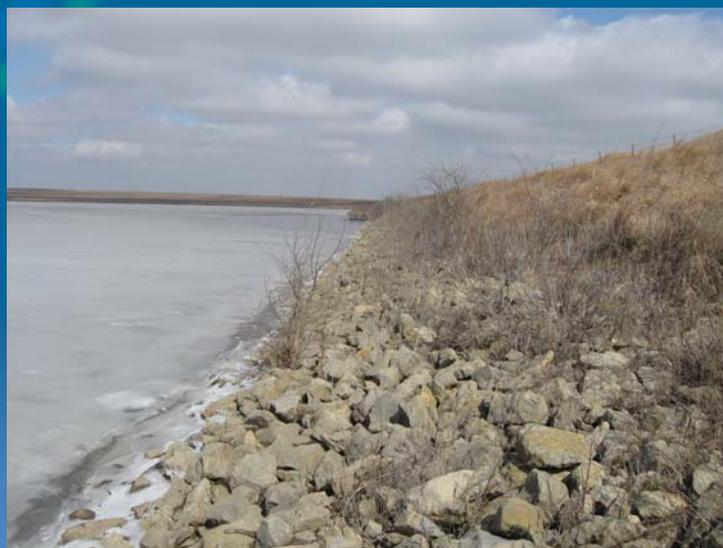
➤ Slope protection

- Rock riprap

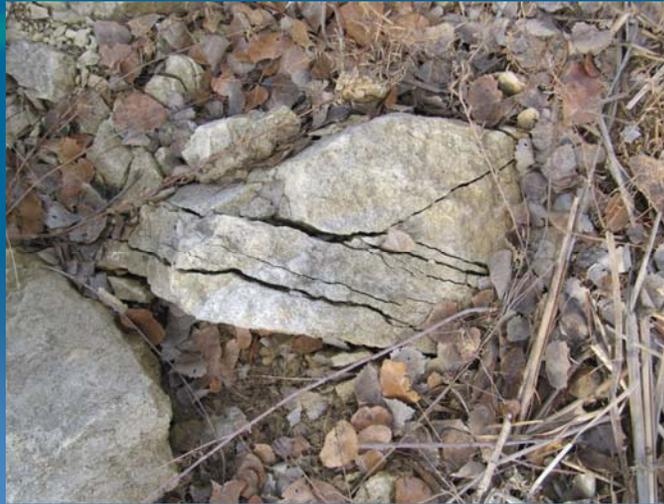
➤ Riprap Slope Protection

- Look for breakdown of rock—may need replacement

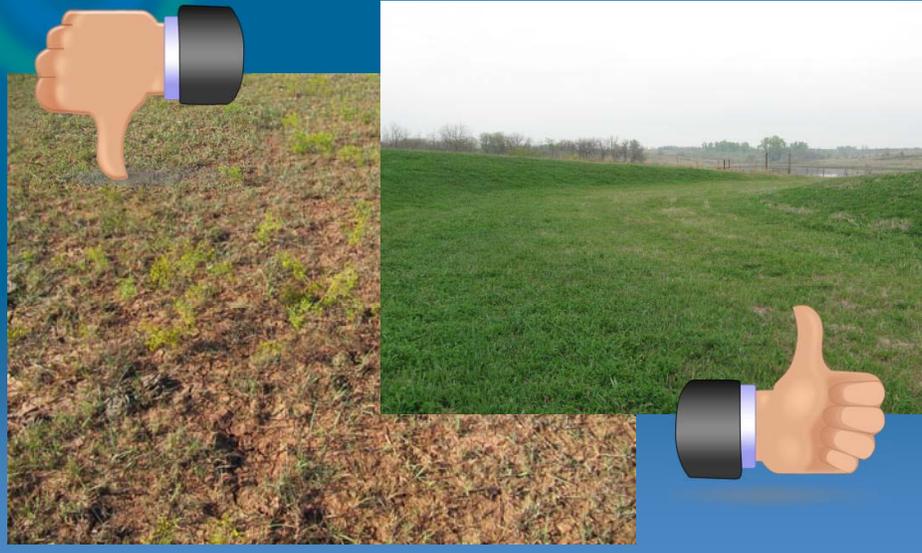
- Auxiliary spillway
 - Vegetation condition

- Adequacy of grass vegetation
- Sloughing, sliding, or erosion of slopes
- Damage by livestock, vehicles, or poor drainage
- Erosion of bottom and exit channel
- Obstructions by woody plants or fences

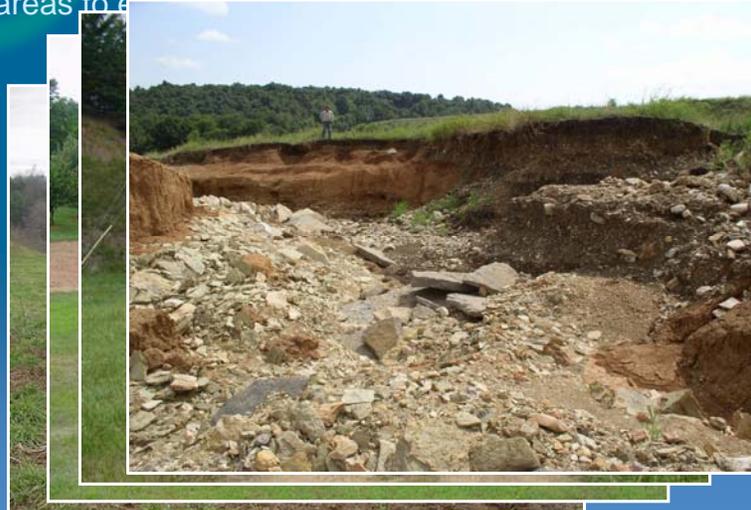
- Auxiliary spillway
 - Obstructions impede flow. Discontinuities cause higher stress during flow—these and bare paths are the first areas to erode during spillway flow.

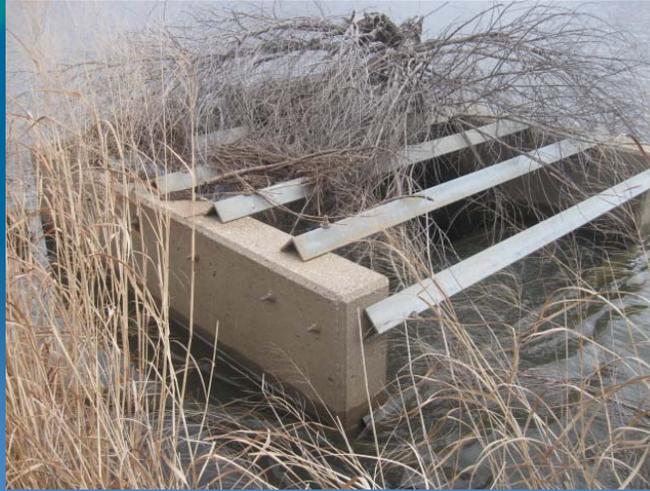
➤ Principal spillway

- Debris and timber should be removed promptly

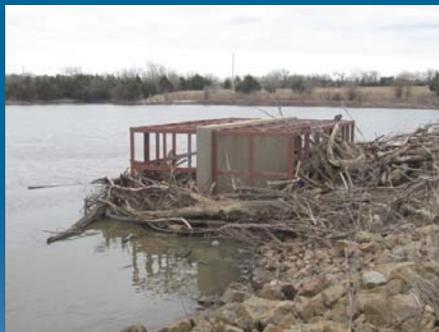
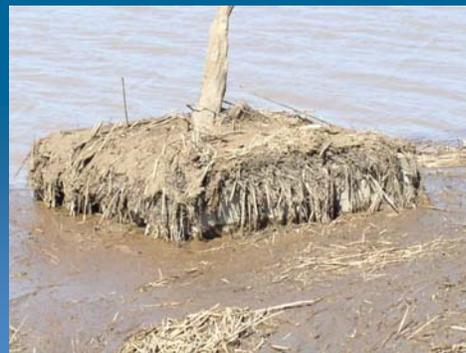
➤ Principal spillway

- Debris and timber should be removed promptly

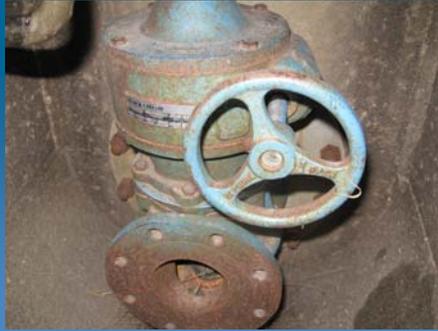
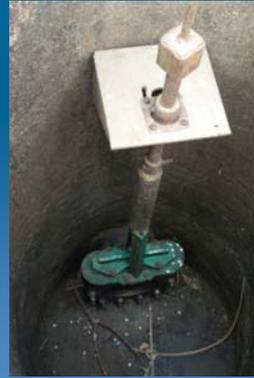
➤ Principal spillway

- Operate the valve annually if possible
 - Tests the functionality of valve and any stem extension hardware
 - Cleans dirt and debris within valve
 - Helps flush sediment accumulation at inlet of drawdown pipe

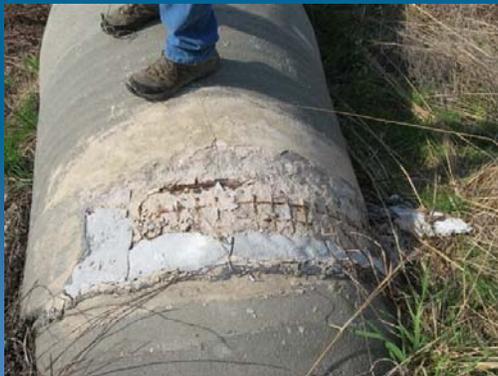
➤ Principal spillway

- Pipe needs some repair patching to prevent corrosion of steel cylinder and reinforcement

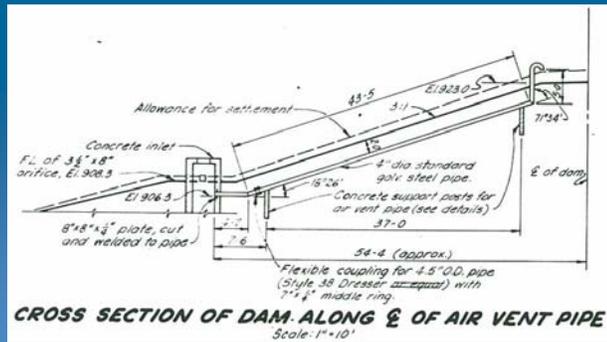
➤ Principal spillway

- Some sites have an air vent—typically a 4" galvanized steel pipe extending above top of dam
- This one has been damaged—possibly by a mower. Need to investigate to determine if pipe is kinked, preventing air flow

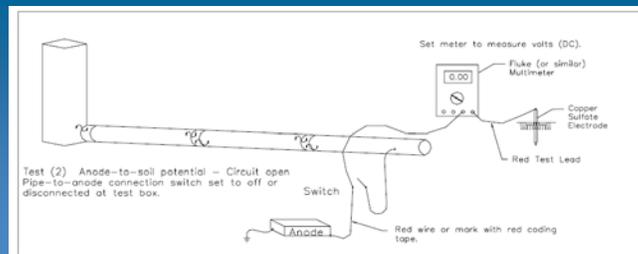
➤ Principal spillway

- Cathodic protection on corrugated metal pipes
 - Extends life of pipe if kept in functional condition
 - System should be tested once every 5 years (request engineering assistance)—NRCS State Office has equipment available
 - Anode and appurtenances need periodic replacement
 - Reference: NEH 650, *Engineering Field Handbook*, Chapter 6, Kansas Supplement

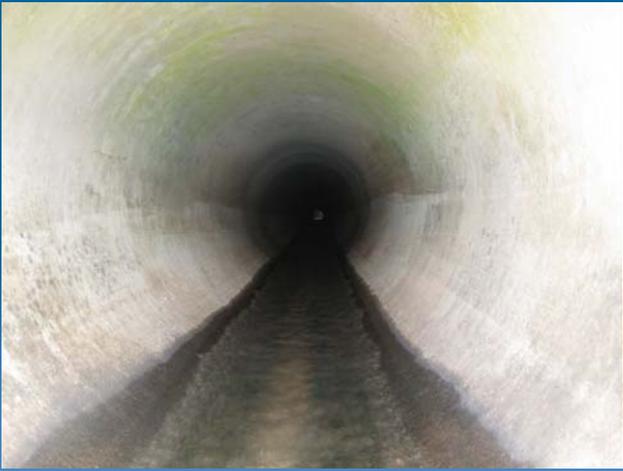
➤ **Principal spillway**

- Occasionally, the interior of a pipe needs to be accessed to check pipe joints or pipe integrity.

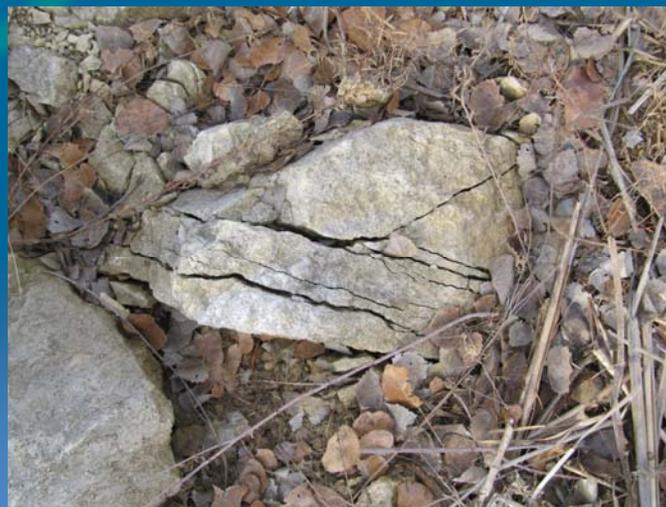
➤ Stilling basin and outlet channel

- Look for breakdown of rock—may need replacement

- Slumping or sliding of slopes
- Displacement or excessive breakdown of riprap materials
- Erosion or siltation of outlet channel
- Seepage or surface runoff into basin
- Excessive vegetation in outlet channel
- Pipe support

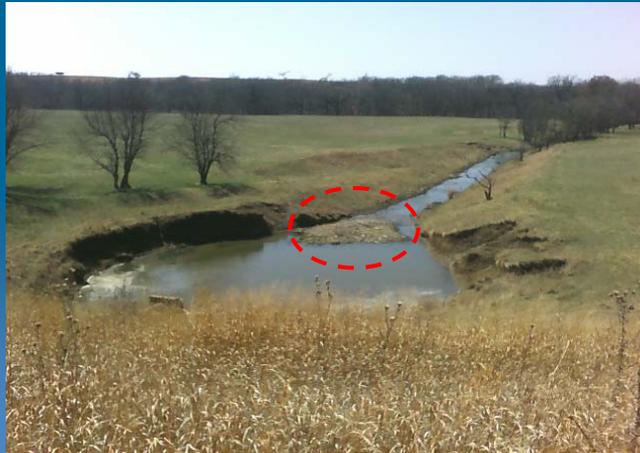
➤ **Stilling basin and outlet channel**

- Erosion and sediment deposition blocking outlet channel may signal need for additional rock riprap

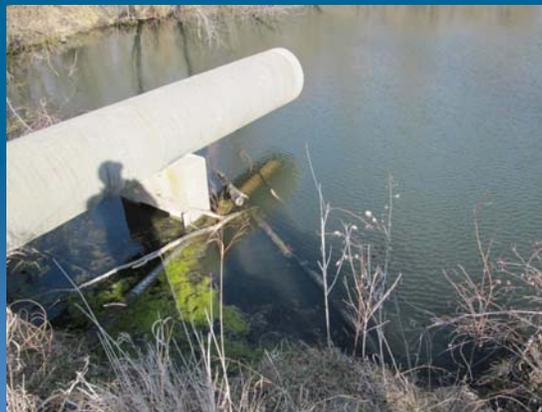
➤ **Stilling basin and outlet channel**

- Drain pipe outlet submerged
- Outlet channel likely has debris that is blocking discharge

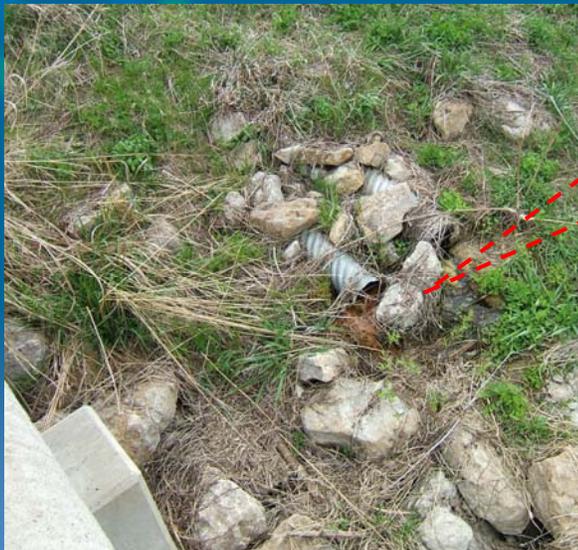
➤ Drain outlets

Remove rocks and debris so pipes can freely discharge

- No flow could mean there is no seepage in area served by drain
- If it flowed previously but not now with comparable pool level, it could mean that the drain is plugged and could lead to slope instability
- A sudden increase in drain flow may indicate that the embankment is less water-tight, possibly due to transverse cracking
- Recording drain flow rates and reservoir levels over time will help in assessing seepage conditions if problems develop

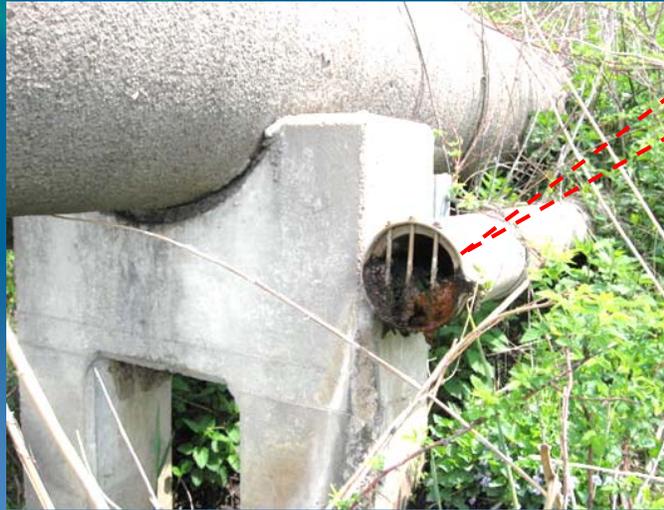
➤ Drain outlets

Needs to be cleaned out

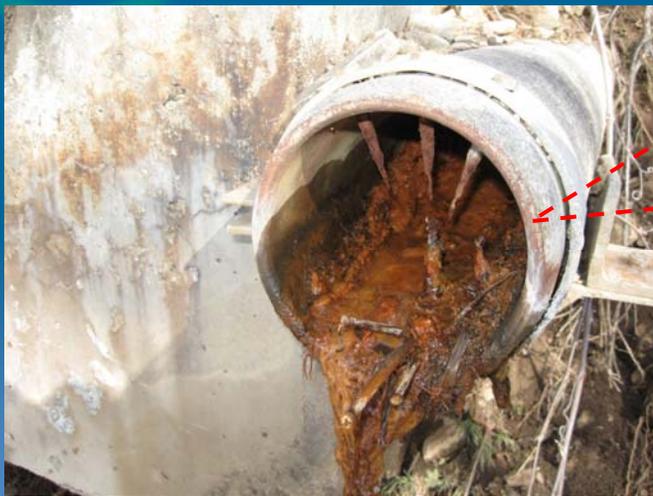
➤ Drain outlets

Needs to be cleaned out and needs new rodent guard

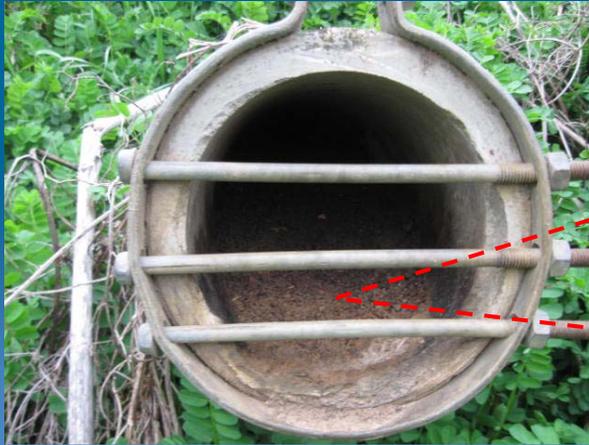
➤ Drain outlets

Drainfill (sand) should not be present in outlet pipe...could mean that collection pipe is damaged or fine sand is entering collection slots

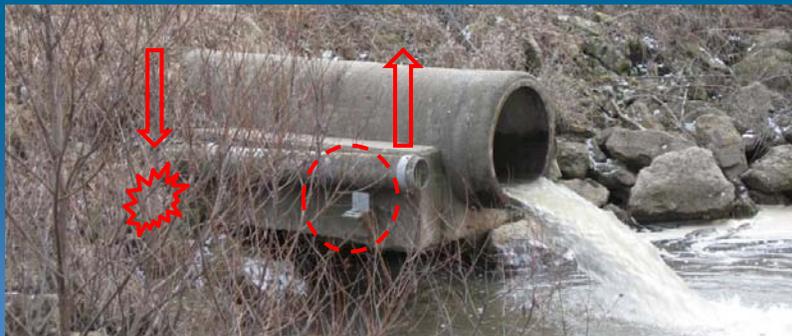
➤ Drain outlets

- Drain outlet pipe is tilted above its support—can happen if additional rock riprap is dumped on slope, fracturing pipe and tilting it up at the end

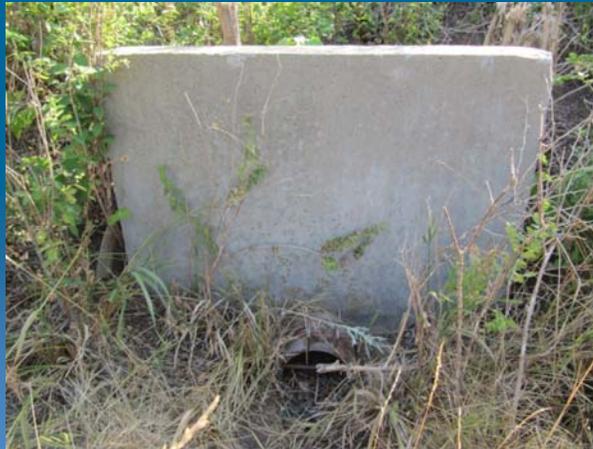
➤ Drain outlets

- Know where to look
- Usually located at the stilling basin, but are sometimes located near the base of abutment at a small headwall

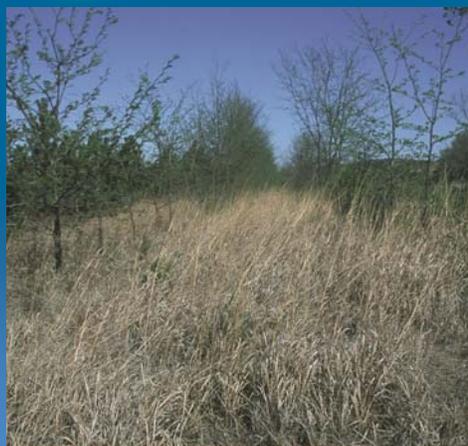
➤ KS-ADS-9, Mitigation Area Inspection Report

- Trees and shrubs
 - Appropriate species with adequate stand
 - Invasion of undesirable species
 - Damage by livestock and/or wildlife
 - Disease affecting stand or individuals
 - Perimeter fence condition

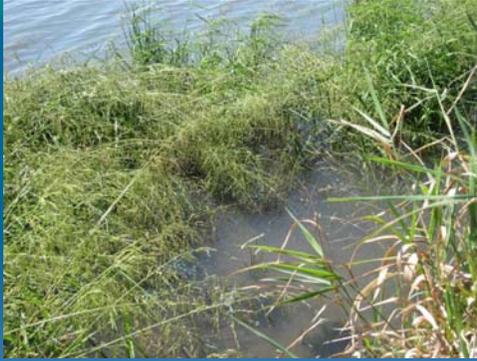
➤ KS-ADS-9, Mitigation Area Inspection Report

- Designed wetlands in reservoir area
 - Invasive species
 - Woody or undesirable debris
 - Damage by vehicles or livestock
